Preliminary Report

**Sioux Silo Failure Investigation
Tepic, Mexico.**

**ESI Project: 47623T
AIG Claim: NX0008863
PP REF.: 12465**

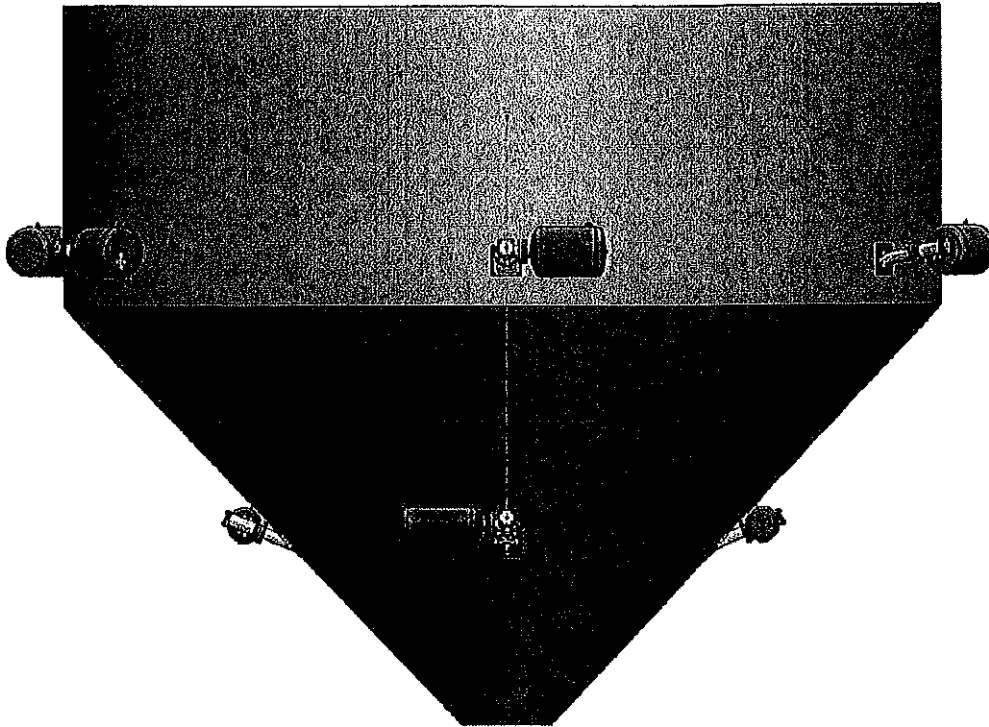
Fig. 4: Air cannons location on the referenced silo.

The referenced hopper-silo was furnished with ten (10) air cannons, six (6) on the bottom of the cylindrical part of the silo (top ones) and four (5) on the hopper section (bottom ones) to help and procure the flow of the stored material out from the bottom of the silo (see Fig. 4). The working mechanism of these cannons is configured in such a way that they operate spurting/discharging dry air (stored pressurized at 140 psi per container) into the interior of the silo, and they are triggered consecutively counter-clockwise every 20 seconds, first the top ones and then the bottom ones, with the purpose of producing a motion of the soybean meal (in this case) which is driven by the air flows at the bottom section of the silo in order to propel/procure the material discharge through the opening of the central bottom cone of the hopper. At this plant, the discharged soybean meal was intended to feed another conveyor, installed at the base of this silo, in order for it to be transported to another part of the plant for further processing.

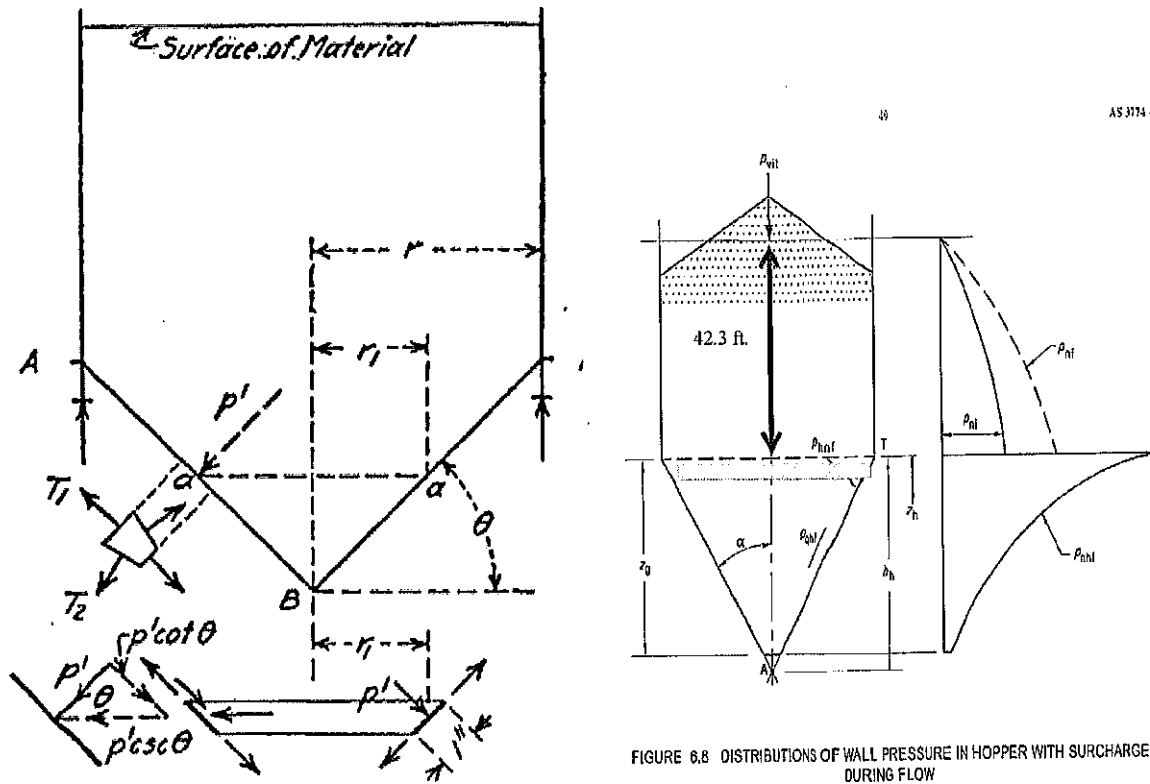
Fig. 6: Pressures on the hopper shell during flow.

The pressures and also in effect the stresses on the hopper wall or shell are different from when the stored material is in stationary mode or condition to the condition; to those of when that material is being discharged or funneled. Fig. 6 shows the normal pressure on the bin walls abruptly increases during the transition from the cylindrical part of the bin to the conical part of the bin; during flow of the material (or funneling condition).

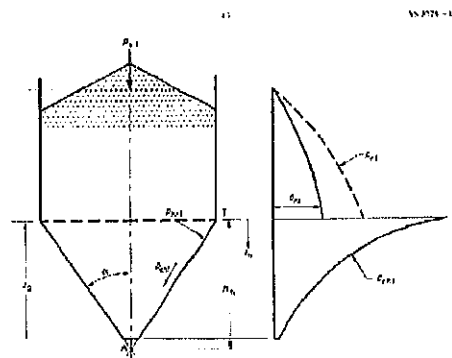
FIGURE 6.8 DISTRIBUTIONS OF WALL PRESSURE IN HOPPER WITH SURCHARGE DURING FLOW

6.3.5 Normal pressures on hoppers The normal pressure on the walls of a hopper during flow is non-uniform (see Figure 6.8). The pressure distribution on the hopper shall be determined from the following equation:

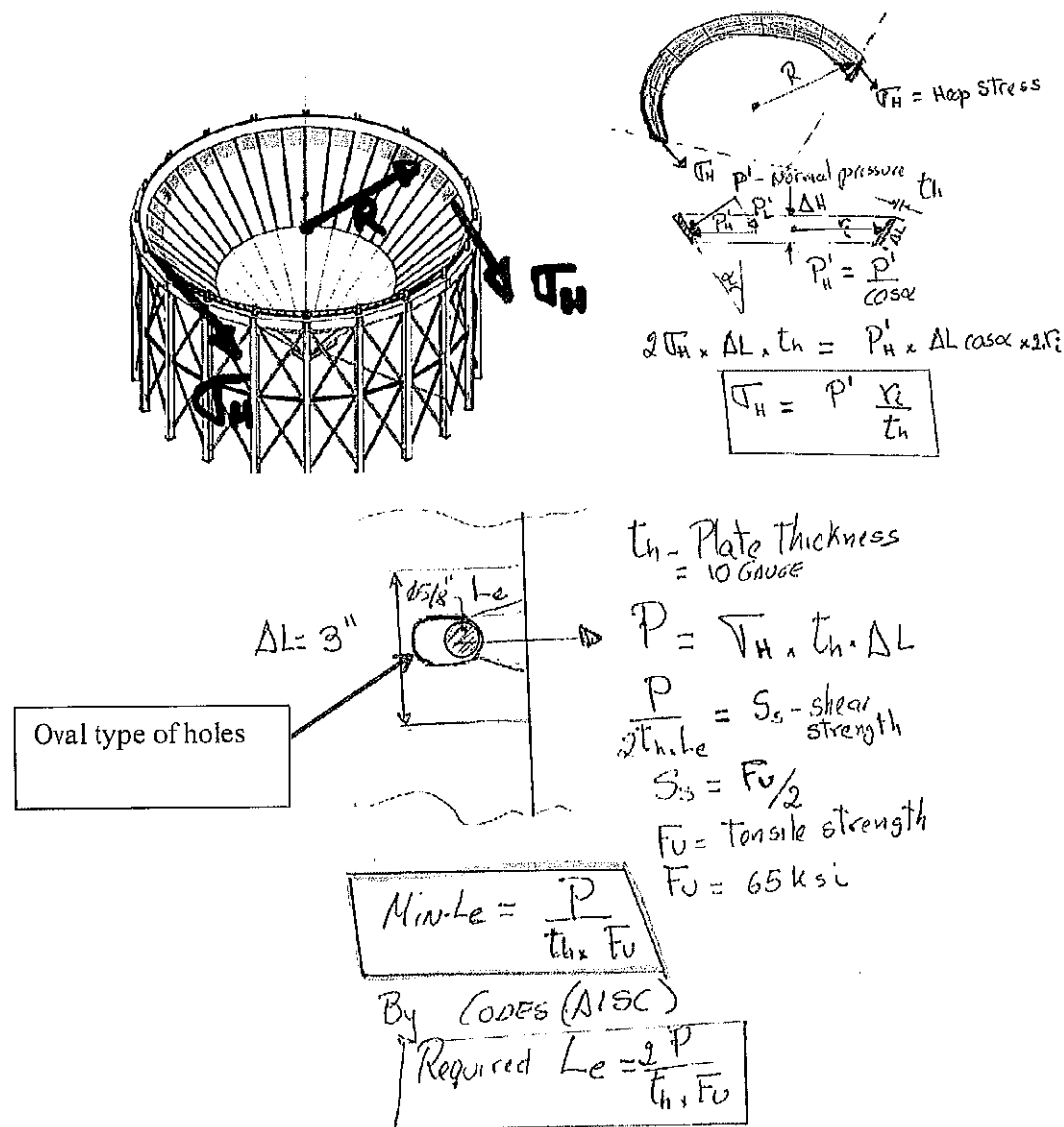
Fig. 7: Stresses on the hopper during flow and Minimum distance required for the bolted connection.

The hoop stresses (σ_h) are proportional to the normal pressure (p') and the radius ' r_i ' and inversely proportional to the thickness of the shell on the circumferential/circular cross section of the cone.

Table 1 and Table 2 also show the calculation of the generated hoop stresses at three critical points on the cone, starting at the edge or transition point cylinder-cone point at 42.2 ft. down to 44.5 ft. Although the normal pressure on the hopper shell increased at the lower circular strips of the cone, the hoop stress would decrease as the radius of the radius of the circular sections (cone) become smaller (see Fig. 7).

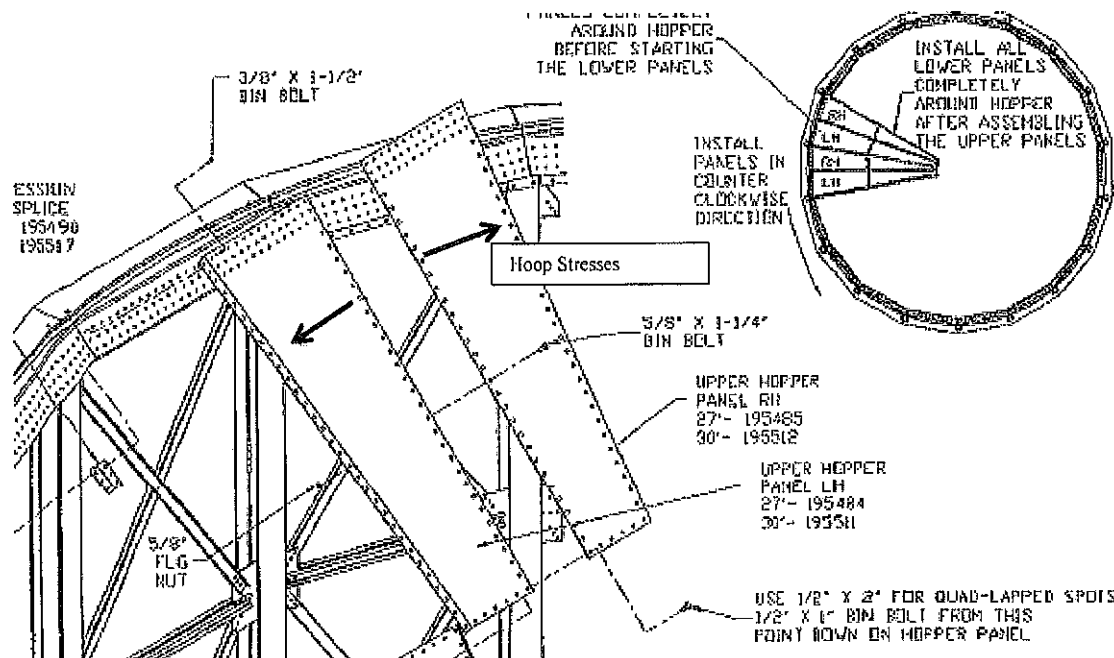
Fig. 8: Hoop/Circumferential Stresses.

The hoop stress at each circular section of the conical hopper would be transmitted from the laminate to adjacent laminate through/by the bolted connection between those panels (see Fig. 8) and as it was stated earlier in this report those hoop acting perpendicular to the seams, would pull the seams apart.
